Analysis

NORTHEAST CAMPUS

TARRANT COUNTY
COLLEGE DISTRICT

Circulation

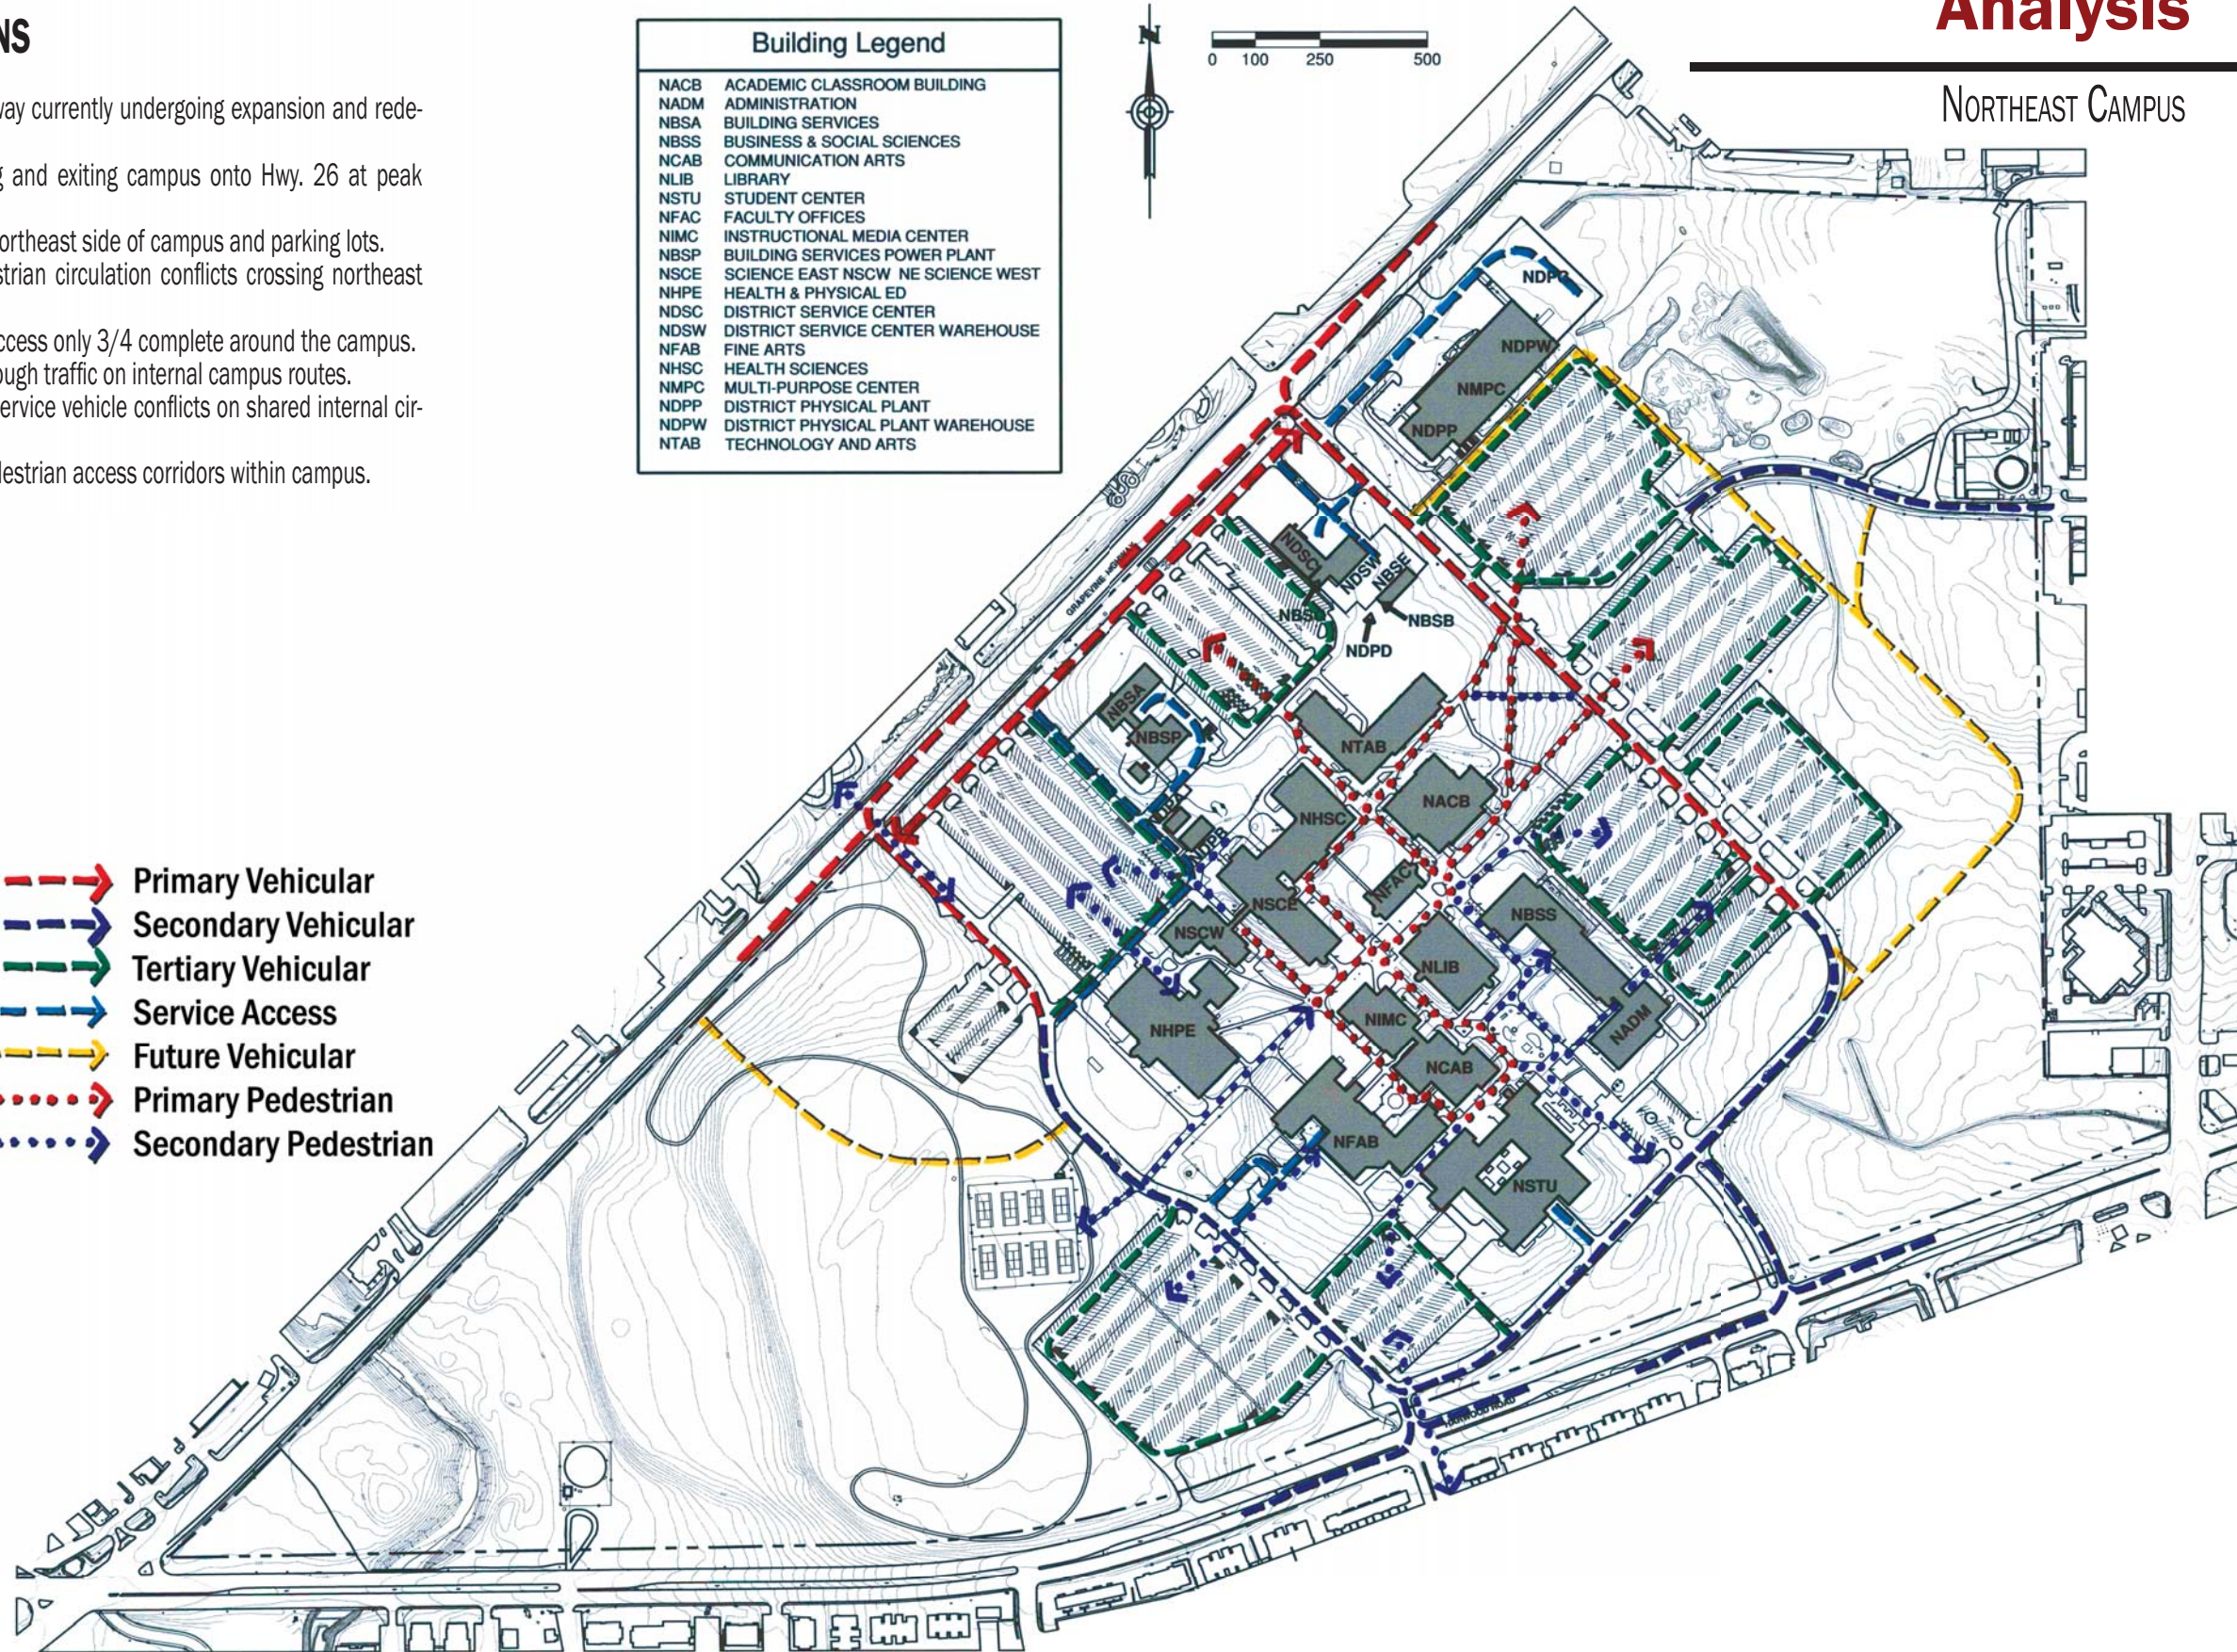
- Hwy. 26 right-of-way currently undergoing expansion and redesign.
- Difficulty entering and exiting campus onto Hwy. 26 at peak times.
- Heavy traffic on northeast side of campus and parking lots.
- Dangerous pedestrian circulation conflicts crossing northeast loop road.
- Clear loop road access only 3/4 complete around the campus.
- Excessive cut-through traffic on internal campus routes.
- Automobile and service vehicle conflicts on shared internal circulation routes.
- Clear internal pedestrian access corridors within campus.
